CHARACTERIZATION OF RSI COATINGS

Ceramic Engineering Division
University of Washington

The Ceramic Engineering Division at the University of Washington has been involved since April 1, 1971, in study of RSI materials under contract NAS2-6541, administered by Ames Research Center. Studies of the coating systems used by the various suppliers were initiated in the fall of 1971.

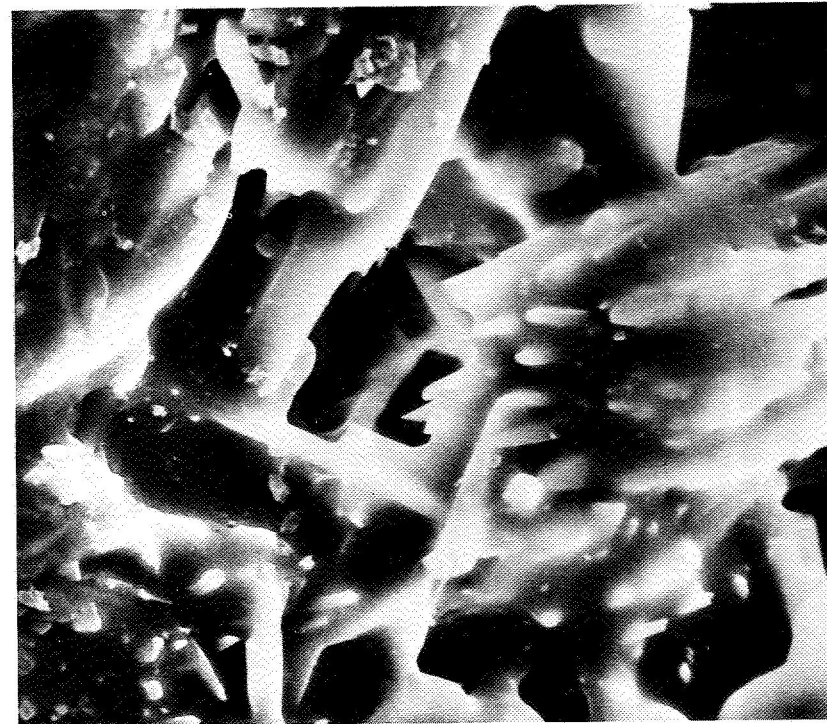
Figure 2 shows the surface of the MOD I coating at two different magnifications. The coating appears porous in figure 2(a), but at the higher magnification (2(b)) it is seen that the crystals are well sealed by the glassy phase.

GE Mod I Coating
As Received
SEM View of Surface

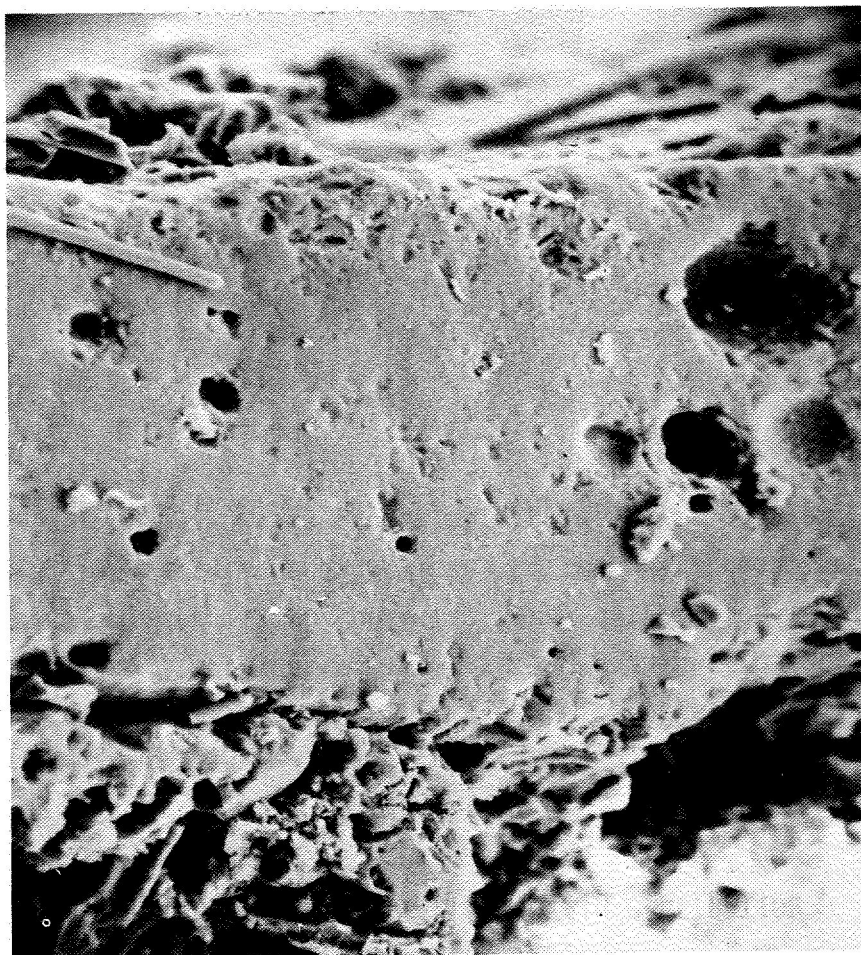
Figure 3 shows a cross-section of the MOD I coating. It appears reasonably dense, with only occasional large porosity.

GE Mod I Coating
As Received
Cross-section of Coating and Interface

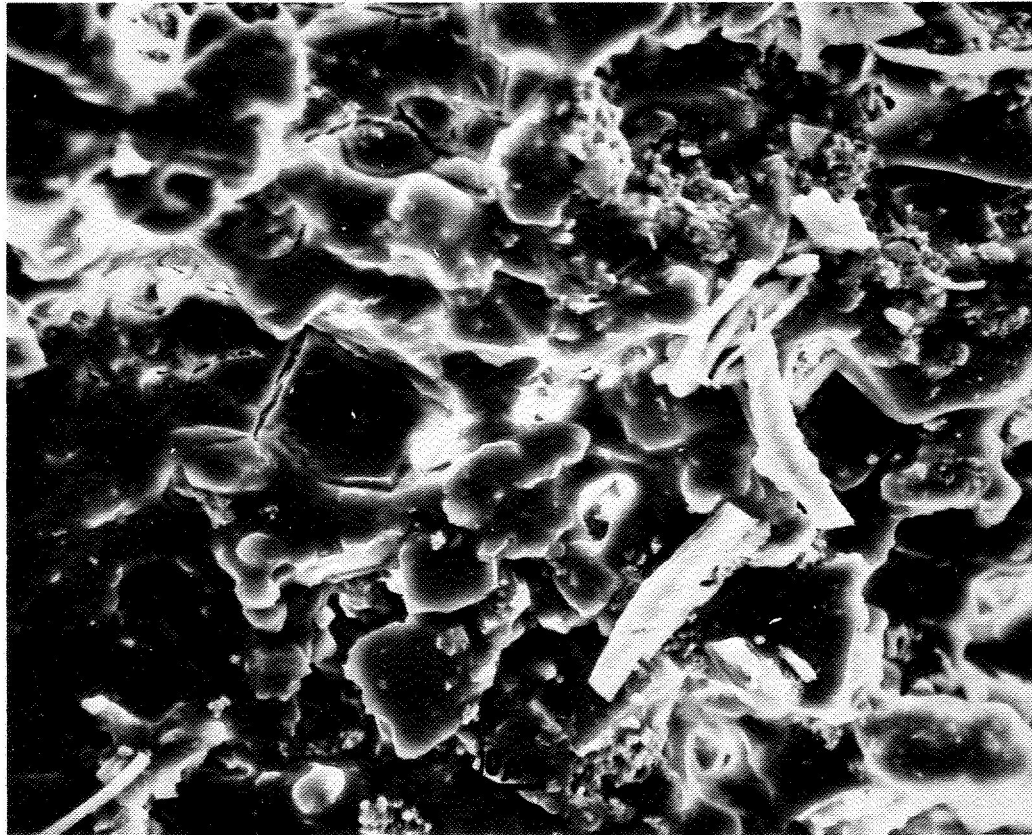
Figure 21 is a view of the LI-1525 surface. The surface appears well sealed by the glass phase.

LMSC LI-1525 Coating
Surface of As-received Coating
